## **Solar Cell Microcracks Are Inevitable, And idealPV FOZHS Makes Them Irrelevant**

Solar cell microcracking is inevitable, but crack induced catastrophic failure doesn't have to be.

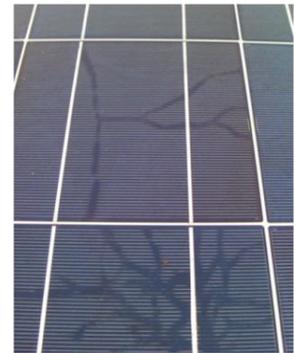
Fig. 9: Microcrack shadows

When a section of the microcrack melts through, it can propagate further breakdown sites along the microcrack, allowing more conduction and melting. This progression of the hotspot along a microcrack forms a trail of delaminated EVA between the front of the cell and back of the front glass. Operators and installers see this often enough that they variously describe it as a “worm track” or “snail trail” (Fig. 9). Since it is rarely possible to see the actual microcrack without special equipment, solar manufacturers often call these “crack shadows”. The thermal shocks of the successive melts can also help propagate the crack.

As a result, the solar panels in figures 1, 2, 3 and 9 are post sale, latent failures of production units which were believed to be safe when they were installed. Figures 1, 2 and 9 are of commercially deployed solar panels in the field. Although Figure 3 was an induced failure in a laboratory, the solar panel was commercially available and the failure was typical.

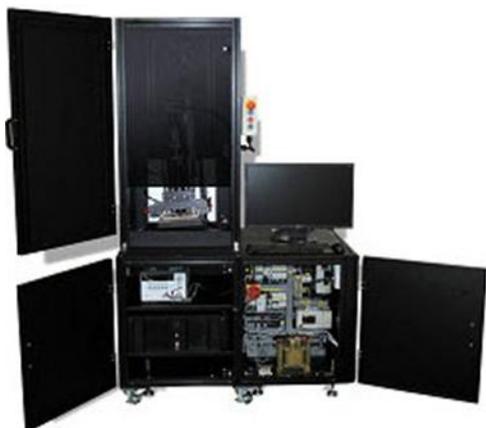
Fig. 11: Chinup Technology Co EL-CT01A

Microcracks do not normally cause a power loss, and thus cannot be detected on a flash tester. Several pieces of specially built EL or IR thermography equipment must be inserted into several points in the solar manufacturing process to detect them. The purpose of this equipment is to reject wafers, cells, strings or even entire solar panels. None of this is necessary using idealPV technology.

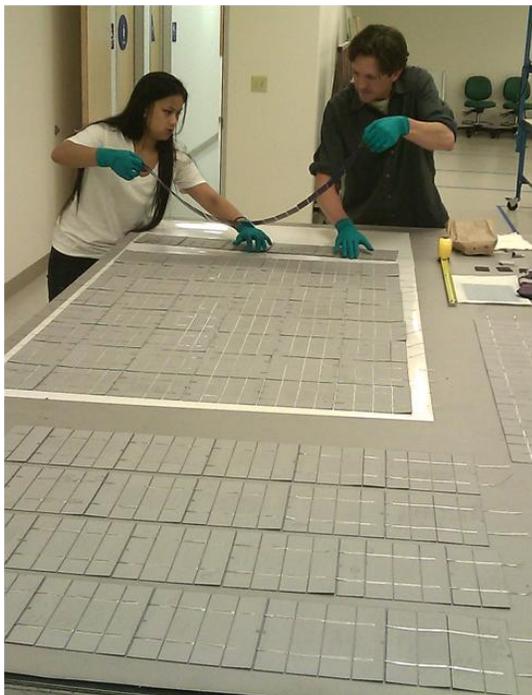
Fig. 13: An idealPV solar panel is assembled from low cost, low reverse breakdown solar cells.
